**Flood Control Project Maintenance
Levee Inspections**

Spring 2012 Levee Inspection Results

Reclamation District No. 1500 Sutter Basin

Levee Inspection Report By Mile - Spring 2012

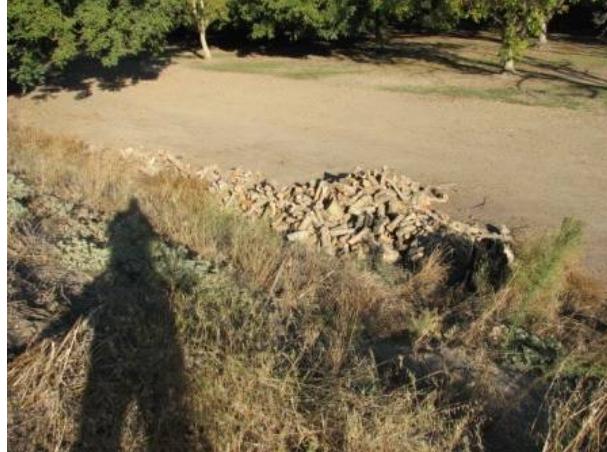
Levee Mile Report Line	4
Start Levee Mile	0.03
End Levee Mile	0.03
Location	Land Side
Category	Earthen Levee
Item	Encroachments
Fresh pile of firewood from this years prunings.	
johngw_s_20120313_361.jpg

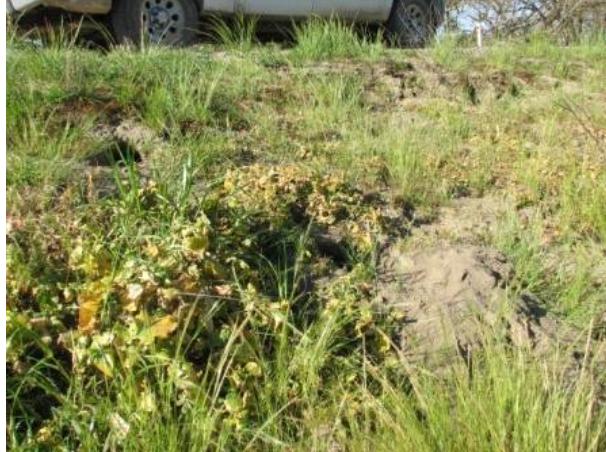
Levee Mile Report Line	5
Start Levee Mile	0.03
End Levee Mile	0.03
Location	Land Side
Category	Earthen Levee
Item	Animal Control
There are multiple rodents hole in the area.	
john gw_s_20120313_367.jpg

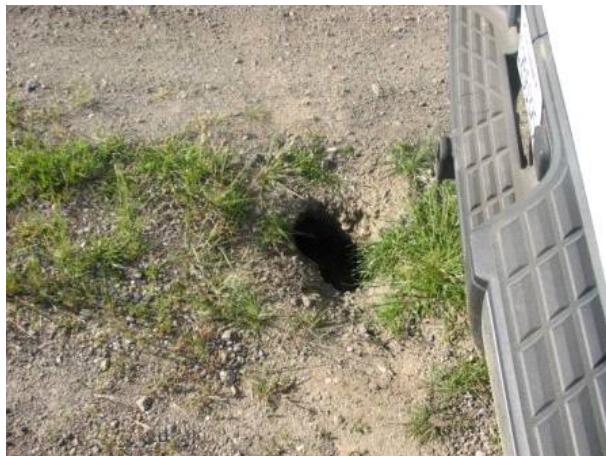
Levee Mile Report Line	6
Start Levee Mile	0.04
End Levee Mile	0.04
Location	Crown
Category	Earthen Levee
Item	Animal Control
A rodent hole in the levee crown, photo taken spring 2012.	
john gw_s_20120409_656.jpg

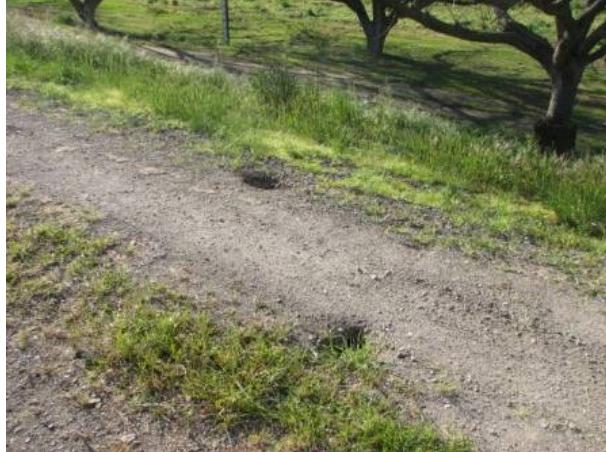
Levee Mile Report Line	6
Start Levee Mile	0.04
End Levee Mile	0.04
Location	Crown
Category	Earthen Levee
Item	Animal Control
Two more rodent hole in the crown, photo taken spring 2012.	
john gw_s_20120409_657.jpg

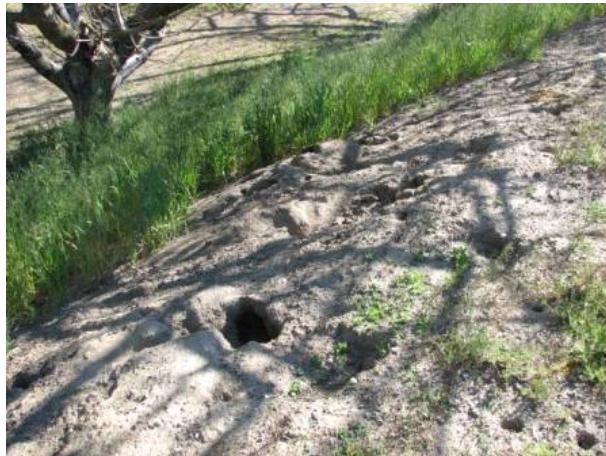
Levee Mile Report Line	9
Start Levee Mile	0.07
End Levee Mile	0.07
Location	Land Side
Category	Earthen Levee
Item	Animal Control
There are some old and a few new rodent holes that need to be backfill.	
john gw_s_20120313_350.jpg

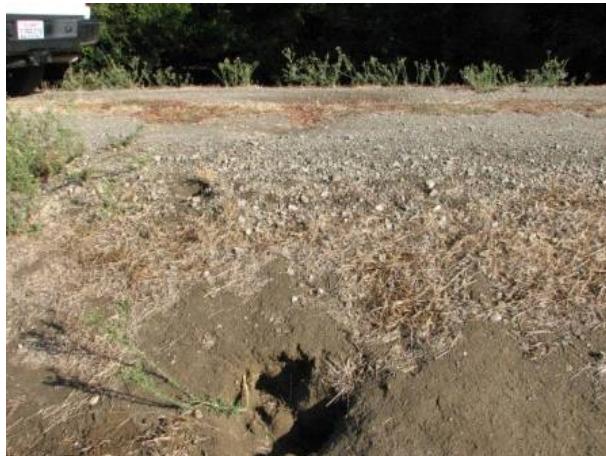
Levee Mile Report Line	11
Start Levee Mile	0.10
End Levee Mile	0.10
Location	Water Side
Category	Earthen Levee
Item	Animal Control
A view of a very large rodent hole on the waterside. Depression are on the crown.	
john gw_s_20120313_416.jpg

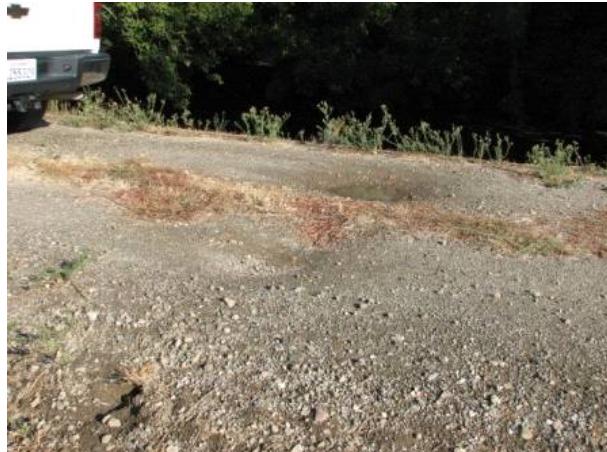
Levee Mile Report Line	11
Start Levee Mile	0.10
End Levee Mile	0.10
Location	Water Side
Category	Earthen Levee
Item	Animal Control
The depression appears to be in line with the rodent holes.	
johngw_s_20120313_417.jpg

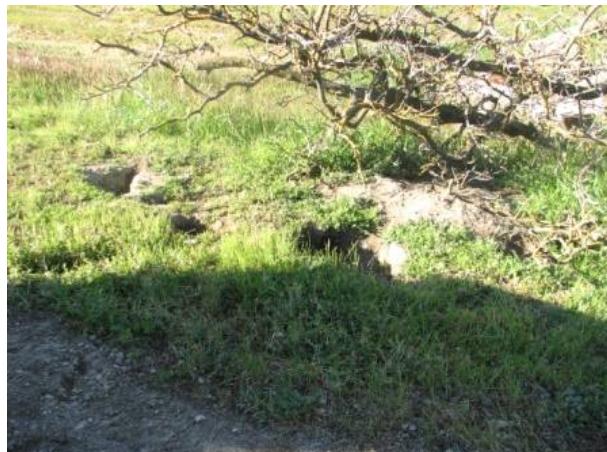
Levee Mile Report Line	12
Start Levee Mile	0.28
End Levee Mile	0.28
Location	Water Side
Category	Earthen Levee
Item	Animal Control
Several rodent holes on the waterside levee slope, photo taken spring 2012.	
johngw_s_20120409_658.jpg

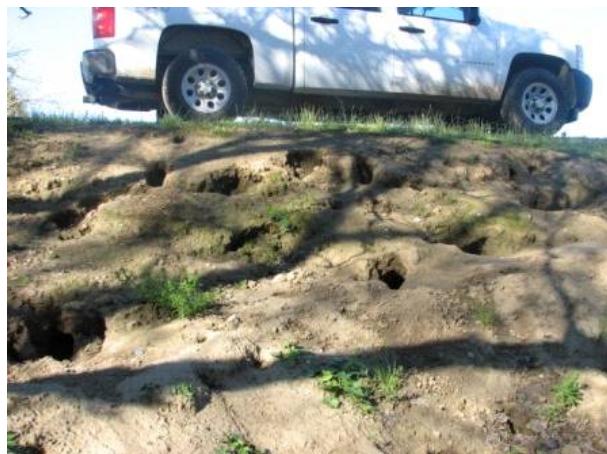
Levee Mile Report Line	13
Start Levee Mile	0.30
End Levee Mile	0.30
Location	Land Side
Category	Earthen Levee
Item	Animal Control
More than five hole in a 25' area, photo taken spring 2012.	
johngw_s_20120409_659.jpg

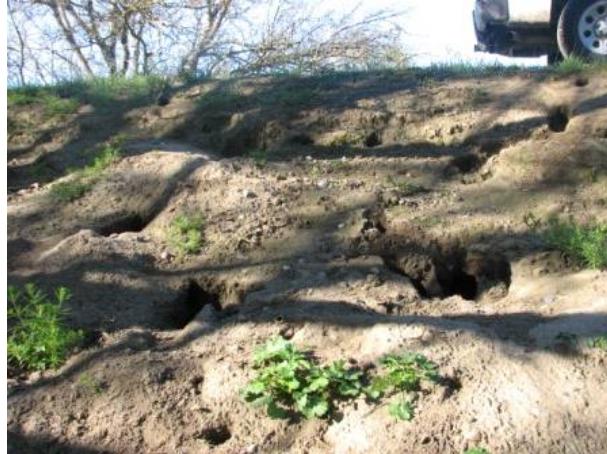
johngw_s_20120409_660.jpg

Second photo of the same area.

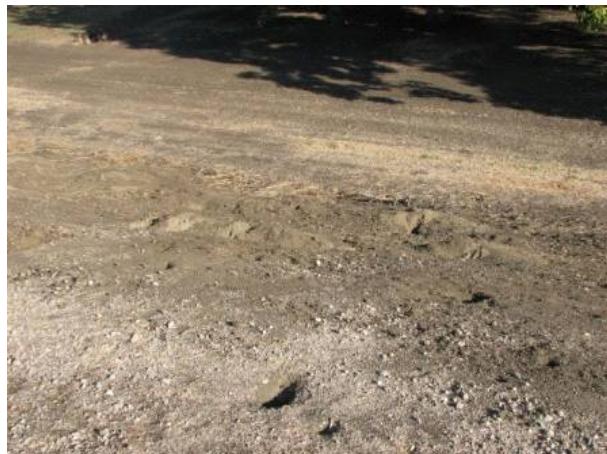
Levee Mile Report Line	14
Start Levee Mile	0.49
End Levee Mile	0.49
Location	Land Side
Category	Earthen Levee
Item	Animal Control

A series of rodent holes on the landside slope and toe of the levee.

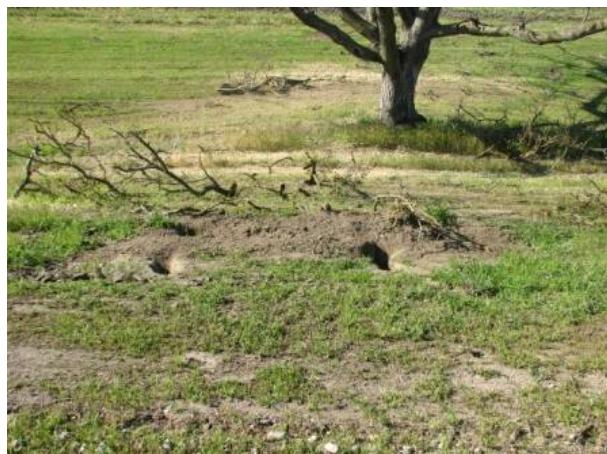
Levee Mile Report Line	15
Start Levee Mile	0.49
End Levee Mile	0.49
Location	Water Side
Category	Earthen Levee
Item	Animal Control

Rodent holes on the waterside across from others on the landside, photo taken spring 2012.

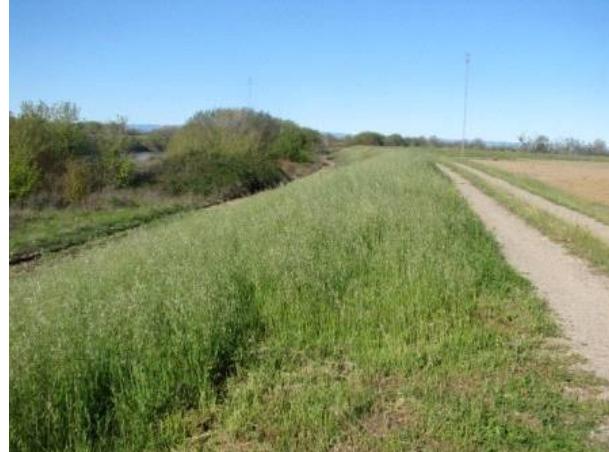
Levee Mile Report Line	16
Start Levee Mile	0.53
End Levee Mile	33.00
Location	Land Side
Category	Earthen Levee
Item	Vegetation
A view of the waterside slope grasses taller than 12", photo taken spring 2012.	
johngw_s_20120409_663.jpg

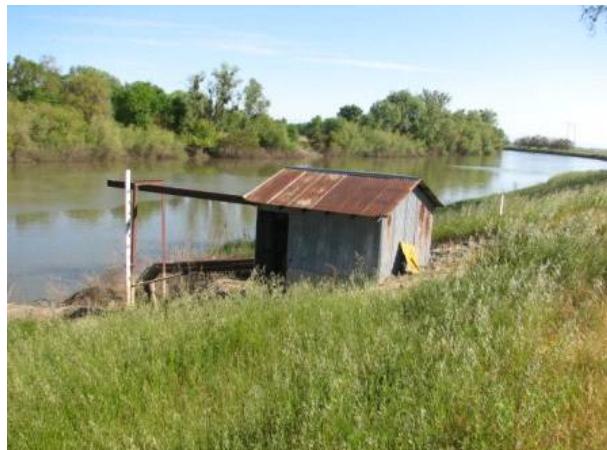
Levee Mile Report Line	19
Start Levee Mile	1.30
End Levee Mile	1.30
Location	Water Side
Category	Earthen Levee
Item	Encroachments

The building is of a pumphouse.

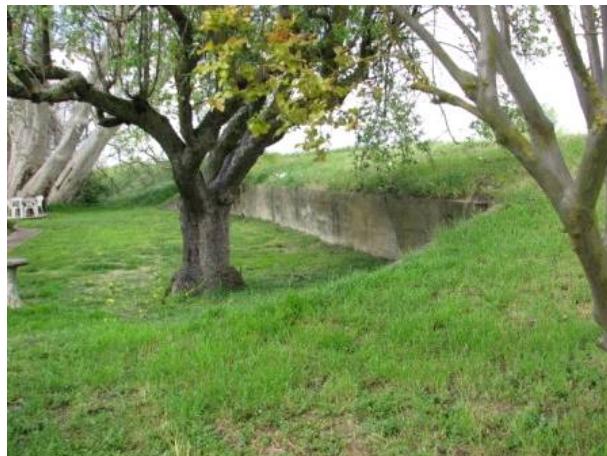
Levee Mile Report Line	21
Start Levee Mile	1.34
End Levee Mile	1.34
Location	Land Side
Category	Earthen Levee
Item	Vegetation

Landscape and retaining wall, this photo is from spring 2010.

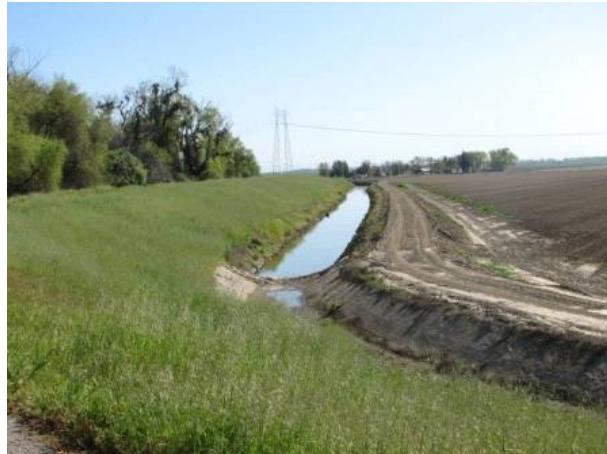
johngw_s_20120313_426.jpg

Agricultural ditch, photo was taken in spring 2010.

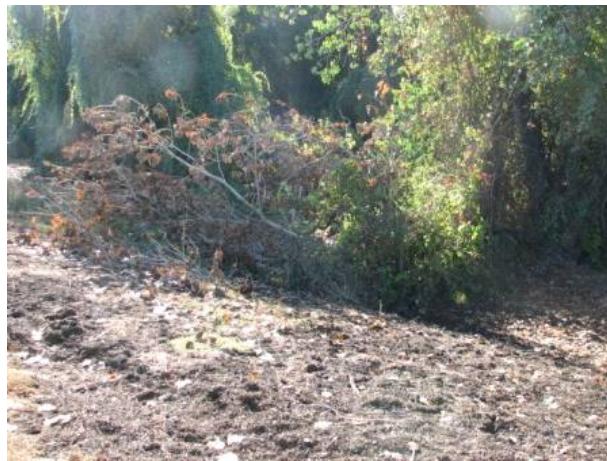
Levee Mile Report Line	25
Start Levee Mile	3.22
End Levee Mile	3.22
Location	Water Side
Category	Earthen Levee
Item	Encroachments

A large tree branch has fallen across the toe of the levee.

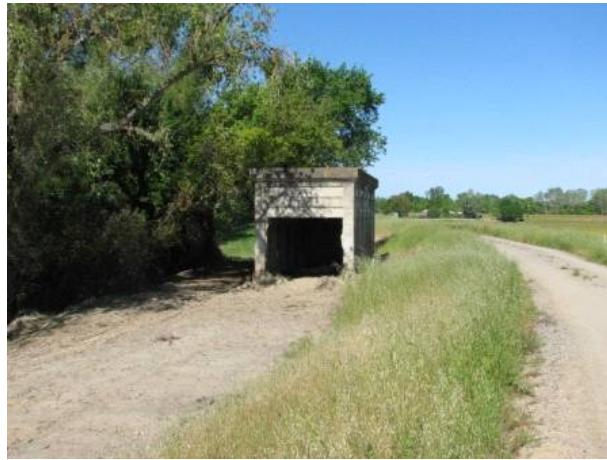
Levee Mile Report Line	26
Start Levee Mile	3.73
End Levee Mile	3.73
Location	Water Side
Category	Earthen Levee
Item	Encroachments

The photo is of the abandoned pumphouse. The district has placed a steel plate over the old outlets. They have began filling the structure for safety.

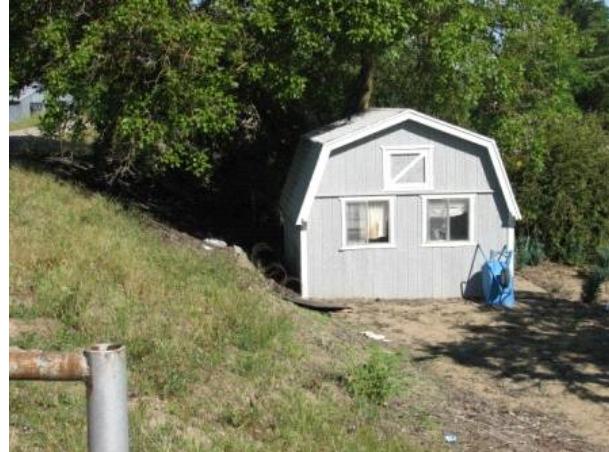
Levee Mile Report Line	27
Start Levee Mile	3.98
End Levee Mile	3.98
Location	Land Side
Category	Earthen Levee
Item	Encroachments
A small building is encroaching into the landside levee toe.	
johngw_s_20120313_352.jpg

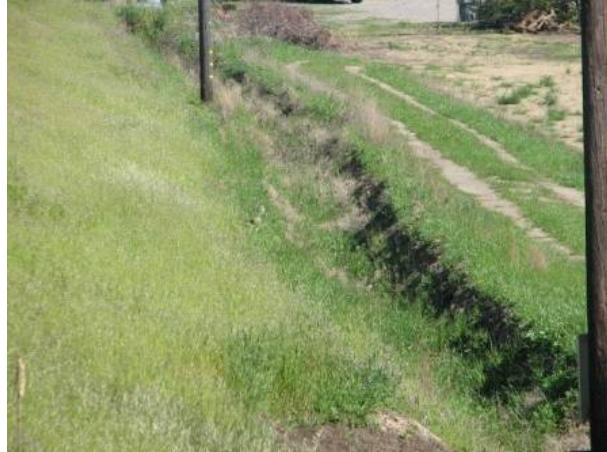
Levee Mile Report Line	30
Start Levee Mile	4.04
End Levee Mile	4.16
Location	Land Side
Category	Earthen Levee
Item	Encroachments
A agricultural ditch runs along the toe of the levee, photo taken spring 2012.	
johngw_s_20120409_666.jpg

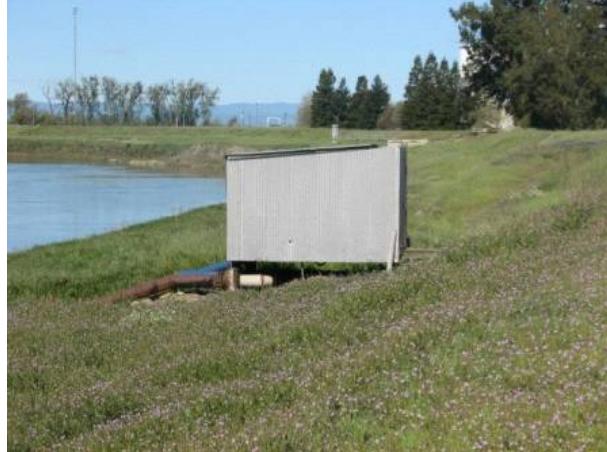
Levee Mile Report Line	33
Start Levee Mile	5.23
End Levee Mile	5.23
Location	Water Side
Category	Earthen Levee
Item	Encroachments
A pump house building is on the waterside slope, photo taken spring 2012.	
<i>johngw_s_20120409_667.jpg</i>

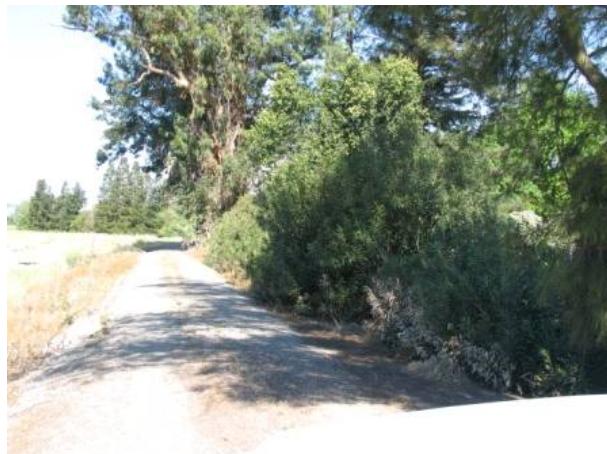
Levee Mile Report Line	34
Start Levee Mile	5.38
End Levee Mile	5.38
Location	Land Side
Category	Earthen Levee
Item	Vegetation
The landscape completely blocks the landside slope and toe.	
<i>johngw_s_20120313_360.jpg</i>

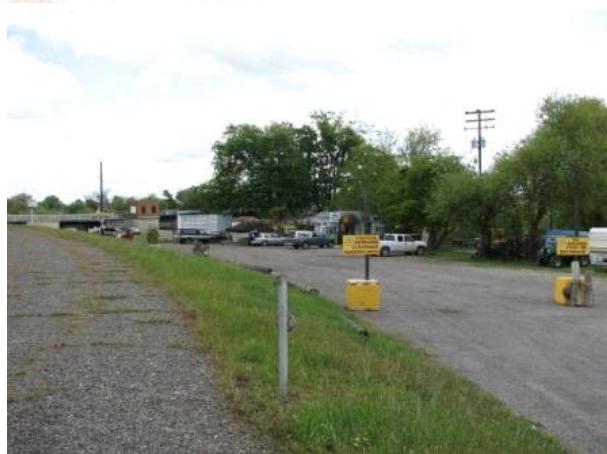
Levee Mile Report Line	35
Start Levee Mile	5.67
End Levee Mile	5.75
Location	Water Side
Category	Earthen Levee
Item	Encroachments
Stingrays Marina RV park, photo was taken in spring 2010.	
<i>johngw_s_20120313_406.jpg</i>

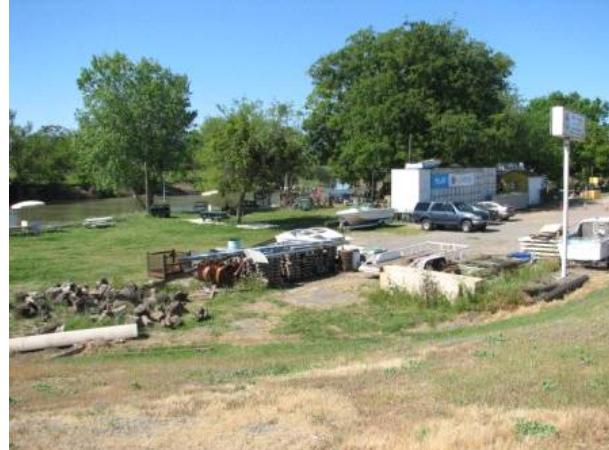
Levee Mile Report Line	35
Start Levee Mile	5.67
End Levee Mile	5.75
Location	Water Side
Category	Earthen Levee
Item	Encroachments
Here is another look at Stingrays Marina and RV park	
johngw_s_20120313_407.jpg

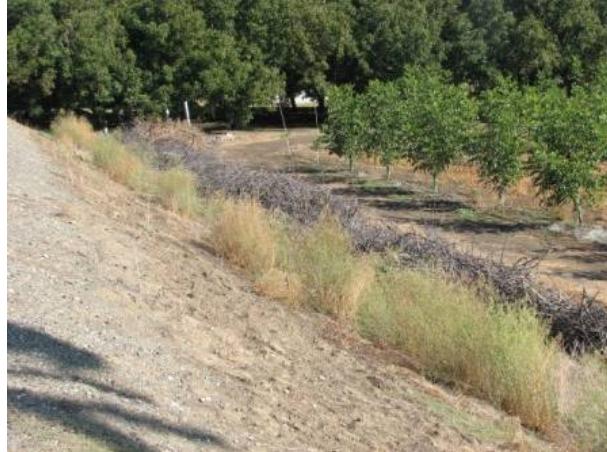
Levee Mile Report Line	36
Start Levee Mile	7.15
End Levee Mile	7.15
Location	Land Side
Category	Earthen Levee
Item	Encroachments
The land owner has piled prunings along the levee toe.	
johngw_s_20120313_421.jpg

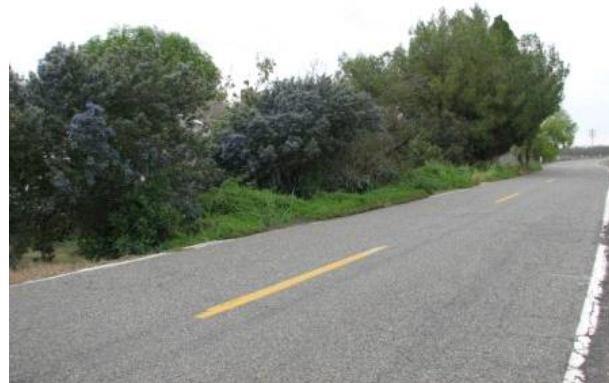
Levee Mile Report Line	39
Start Levee Mile	7.66
End Levee Mile	7.66
Location	Land Side
Category	Earthen Levee
Item	Vegetation
Landscape shrubs, photo taken in spring 2010.	johngw_s_20120313_364.jpg

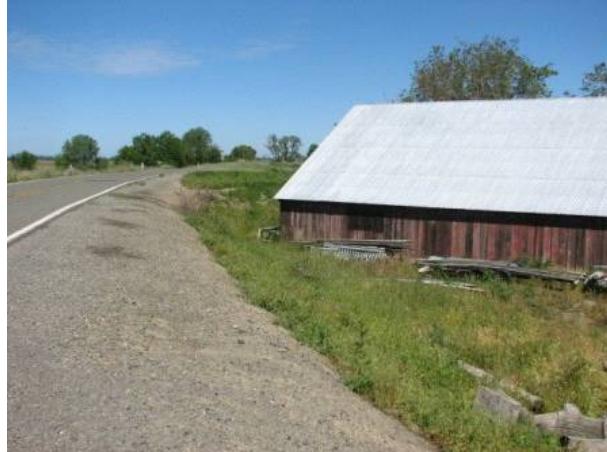
Levee Mile Report Line	43
Start Levee Mile	8.79
End Levee Mile	8.79
Location	Land Side
Category	Earthen Levee
Item	Encroachments
The corner of the building has encroached into the toe.	
johngw_s_20120313_365.jpg

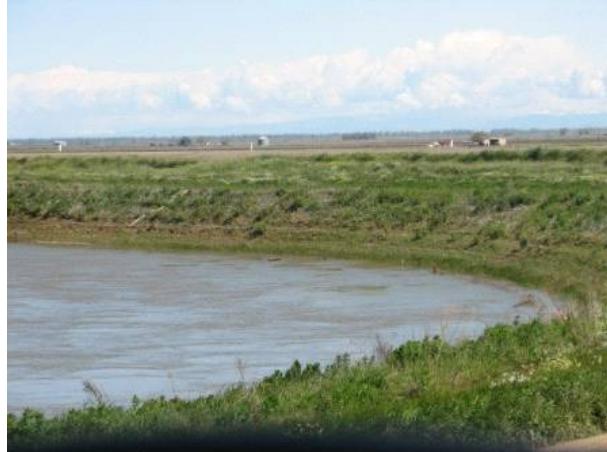
johngw_s_20120409_671.jpg

A revegetation site on the waterside bank with sprinklers installed.

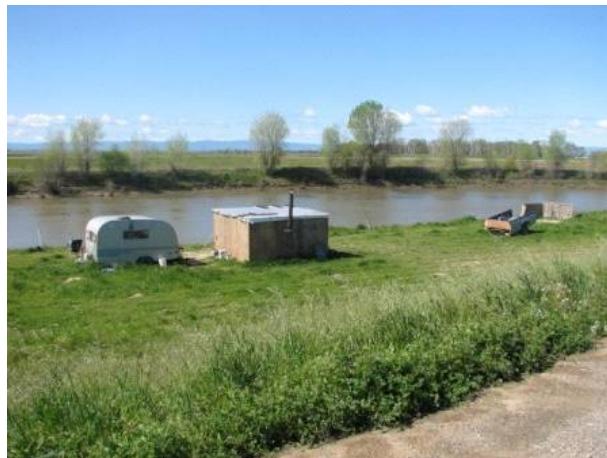
Levee Mile Report Line	46
Start Levee Mile	11.26
End Levee Mile	11.26
Location	Water Side
Category	Earthen Levee
Item	Encroachments

A fishing shack with stove and solar power on waterside berm, photo taken spring 2012.

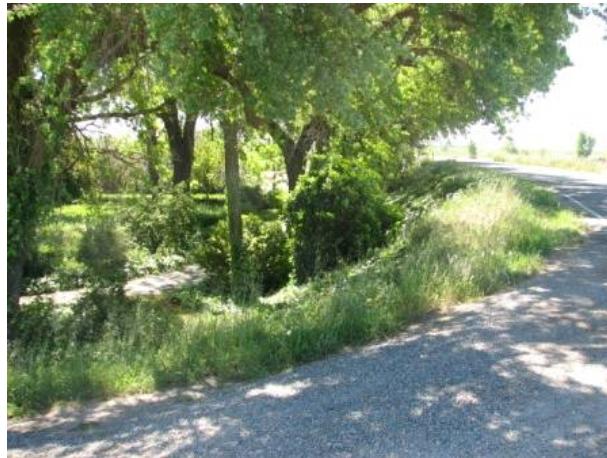
Levee Mile Report Line	47
Start Levee Mile	11.43
End Levee Mile	11.43
Location	Land Side
Category	Earthen Levee
Item	Vegetation

The homeowner has landscaped the levee slope.

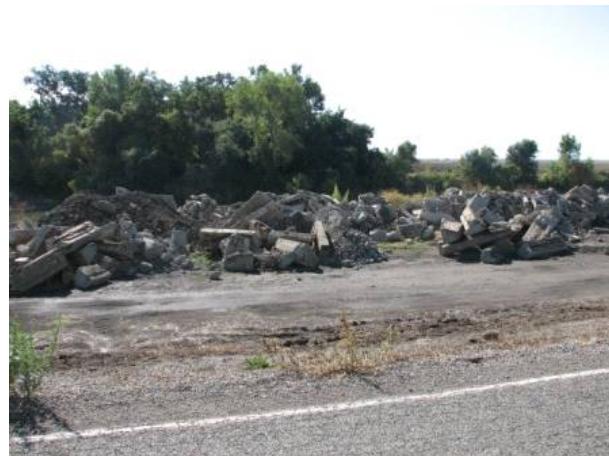
Levee Mile Report Line	49
Start Levee Mile	11.93
End Levee Mile	11.93
Location	Water Side
Category	Earthen Levee
Item	Encroachments

Concrete debris is being stockpiled on the slab of the old loading dock area.

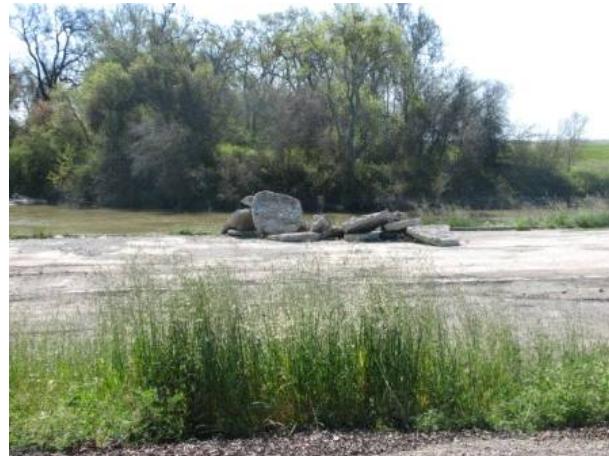
Levee Mile Report Line	49
Start Levee Mile	11.93
End Levee Mile	11.93
Location	Water Side
Category	Earthen Levee
Item	Encroachments

The debris pile has gotten smaller, photo taken spring 2012.

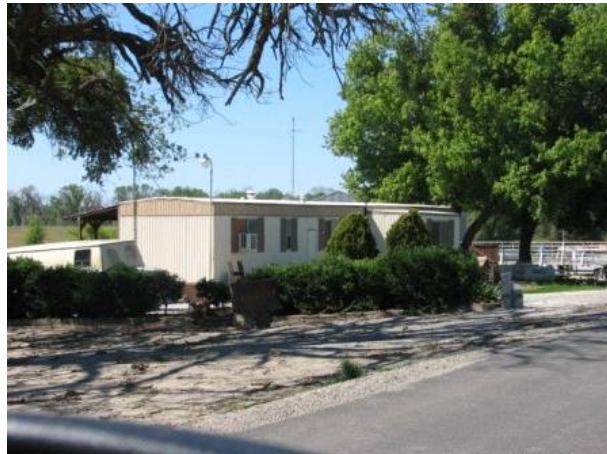
Levee Mile Report Line	53
Start Levee Mile	12.15
End Levee Mile	12.15
Location	Water Side
Category	Earthen Levee
Item	Encroachments

The mobile home is the home of the operator for Sutter Municipile Water.

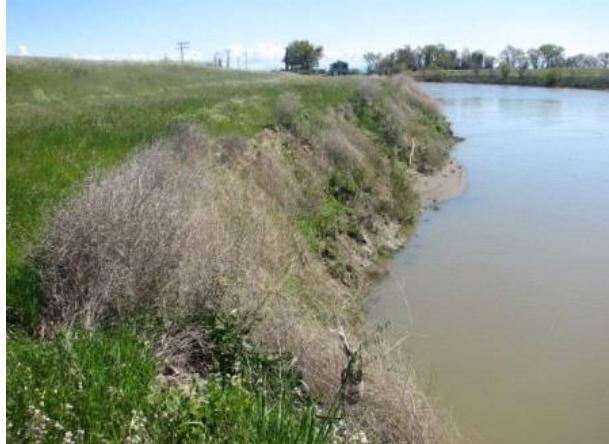
Levee Mile Report Line	54
Start Levee Mile	12.31
End Levee Mile	12.31
Location	Water Side
Category	Earthen Levee
Item	Erosion / Bank Caving
An erosion site along the embankment, photo taken spring 2012.

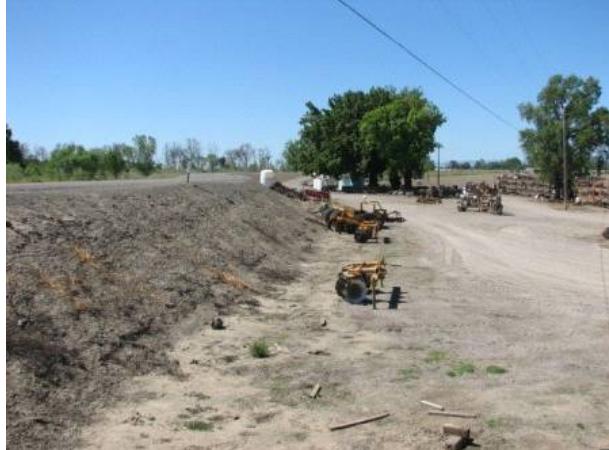
Levee Mile Report Line	55
Start Levee Mile	12.55
End Levee Mile	12.55
Location	Land Side
Category	Earthen Levee
Item	Encroachments
There is equipment parked along the toe of the levee.

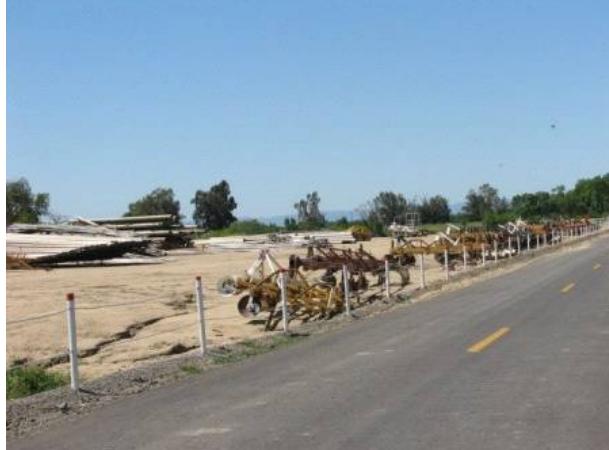
Levee Mile Report Line	56
Start Levee Mile	12.93
End Levee Mile	12.93
Location	Crown
Category	Earthen Levee
Item	Encroachments
On top of the crown is farm equipment and irrigation pipe.

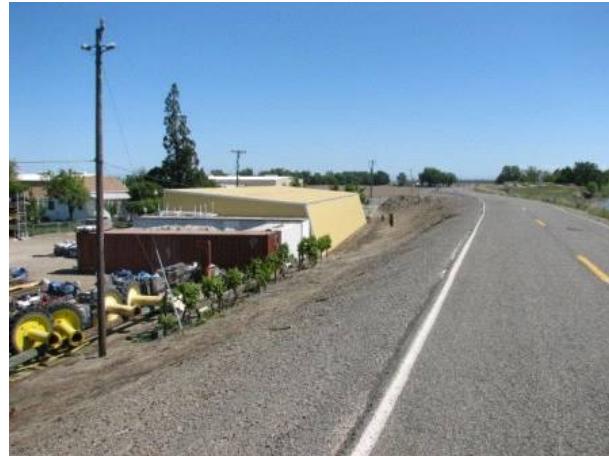
Levee Mile Report Line	57
Start Levee Mile	13.15
End Levee Mile	13.15
Location	Land Side
Category	Earthen Levee
Item	Encroachments
The buildings backside was built into the toe of the levee.	
johngw_s_20120313_375.jpg

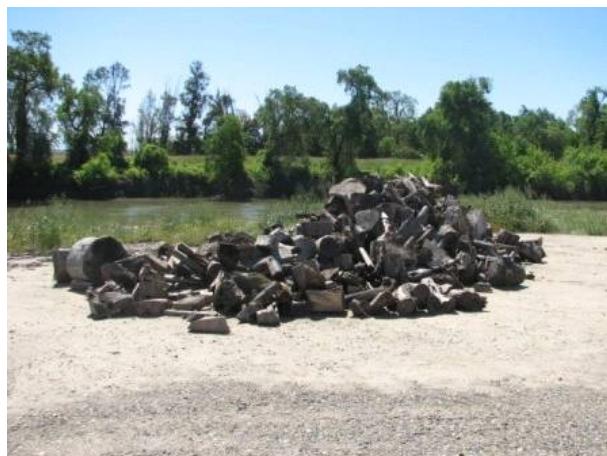
Levee Mile Report Line	60
Start Levee Mile	14.09
End Levee Mile	14.09
Location	Crown
Category	Earthen Levee
Item	Encroachments

Firewood has been stacked on top of the levee crown.

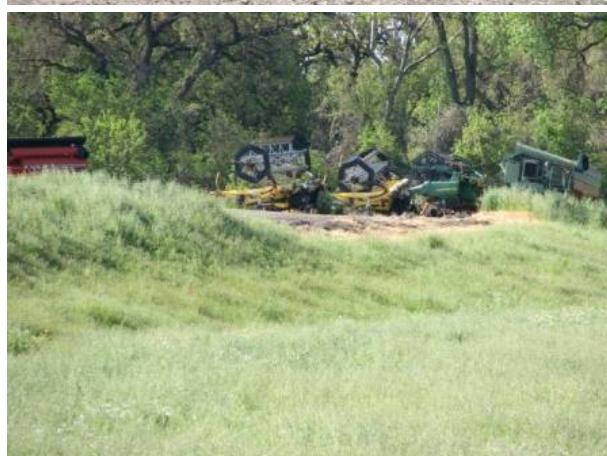
Levee Mile Report Line	61
Start Levee Mile	14.13
End Levee Mile	14.13
Location	Water Side
Category	Earthen Levee
Item	Encroachments

View of equipment. Photo was taken in spring 2010.

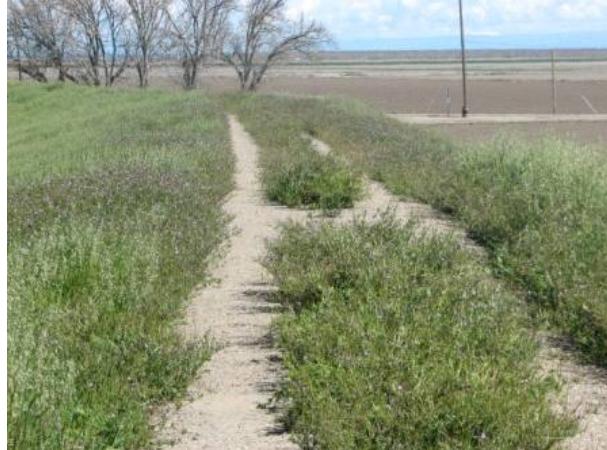
Levee Mile Report Line	62
Start Levee Mile	14.17
End Levee Mile	15.96
Location	Crown
Category	Earthen Levee
Item	Crown Surface / Depressions / Rutting
Control the weeds on the crown, photo taken spring 2012.	
johngw_s_20120409_676.jpg

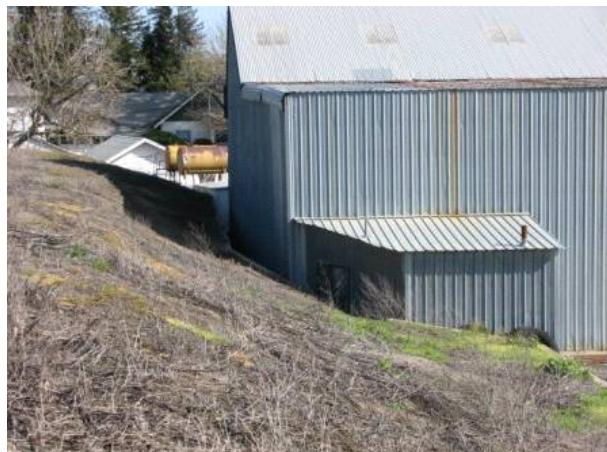
Levee Mile Report Line	63
Start Levee Mile	14.35
End Levee Mile	14.35
Location	Land Side
Category	Earthen Levee
Item	Encroachments
Building and wall into levee. Photo was taken in spring 2010.	
johngw_s_20120313_379.jpg

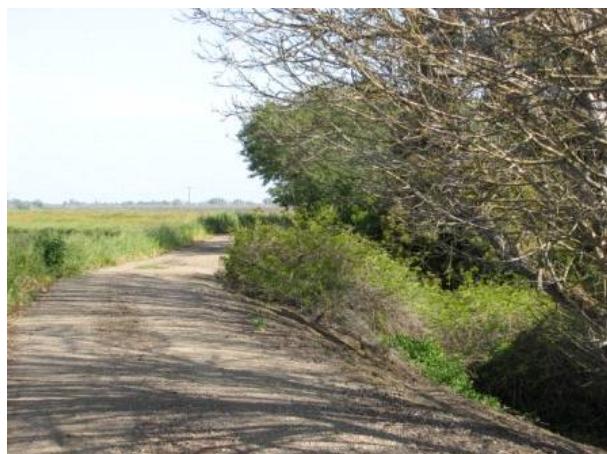
Levee Mile Report Line	64
Start Levee Mile	14.39
End Levee Mile	14.39
Location	Land Side
Category	Earthen Levee
Item	Vegetation
Landscape shrubs on shoulder. Photo was taken in spring 2010.	
johngw_s_20120313_380.jpg

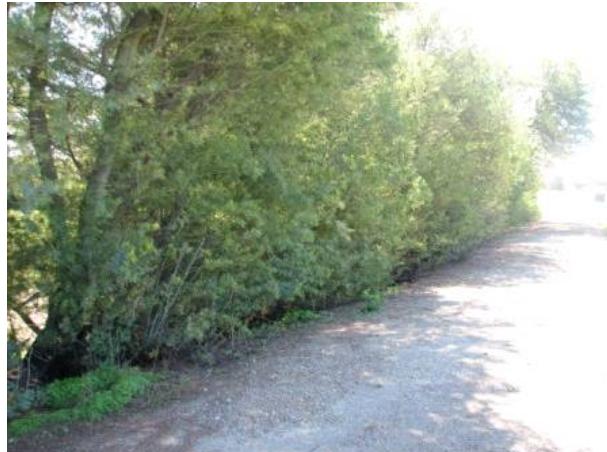
johngw_s_20120409_675.jpg

The trees on the landside slope blocks the view of the slope, photo taken spring 2012.

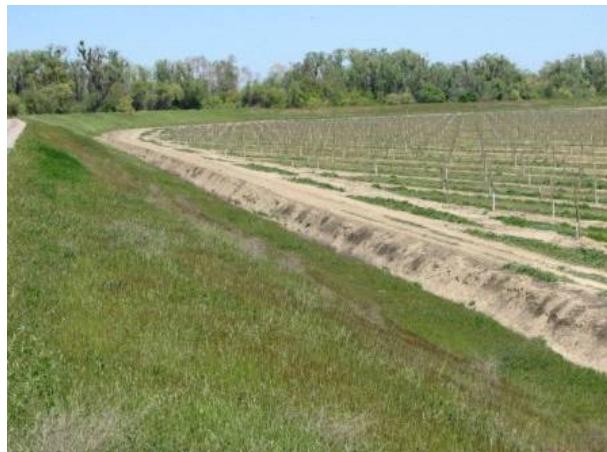
Levee Mile Report Line	66
Start Levee Mile	14.86
End Levee Mile	15.93
Location	Land Side
Category	Earthen Levee
Item	Encroachments

Agricultural ditch, photo taken in spring 2010.

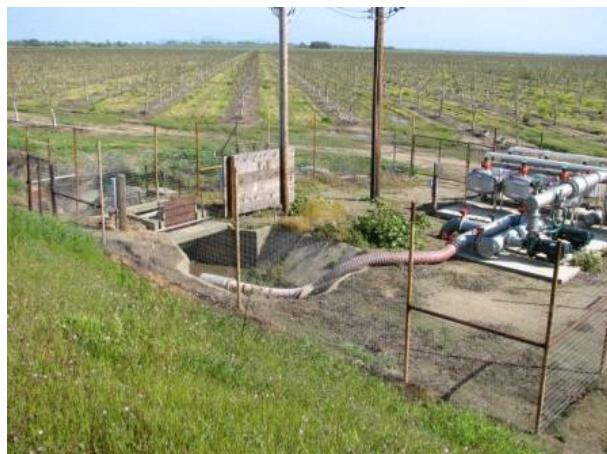
Levee Mile Report Line	67
Start Levee Mile	15.27
End Levee Mile	15.27
Location	Land Side
Category	Earthen Levee
Item	Encroachments

Fence into levee toe, photo taken in spring 2010.

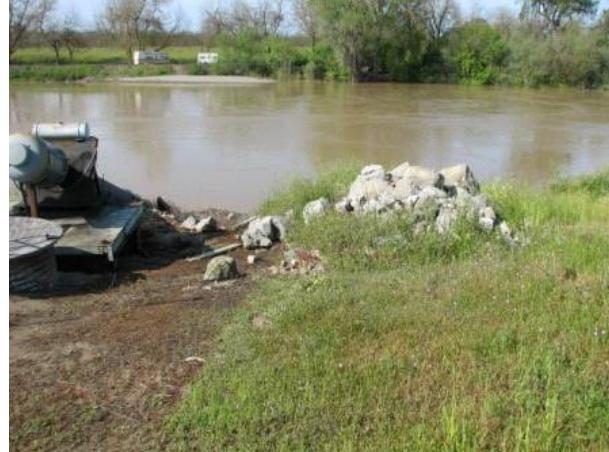
Levee Mile Report Line	68
Start Levee Mile	15.27
End Levee Mile	15.27
Location	Water Side
Category	Earthen Levee
Item	Encroachments
Rip rap and concrete debris, photo taken in spring 2010.	
<i>johngw_s_20120313_370.jpg</i>

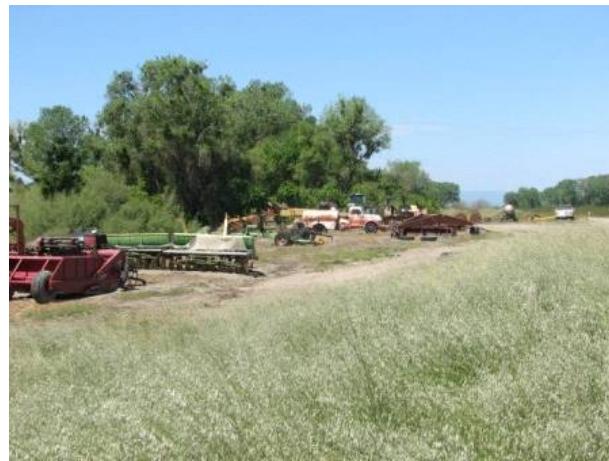
Levee Mile Report Line	69
Start Levee Mile	15.94
End Levee Mile	15.94
Location	Water Side
Category	Earthen Levee
Item	Encroachments
Farm equipment has been parked on the waterside berm.	
<i>johngw_s_20120313_381.jpg</i>

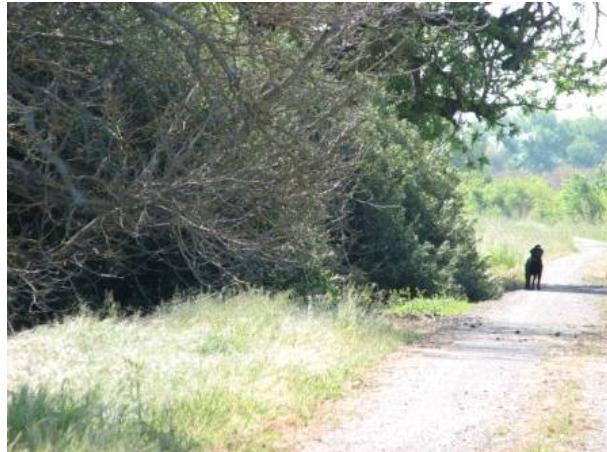
johngw_s_20120313_382.jpg

Landscape shrubs, photo taken in spring 2010.

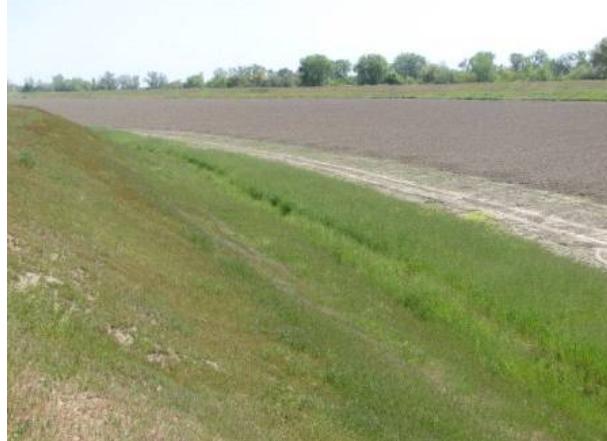
Levee Mile Report Line	72
Start Levee Mile	16.86
End Levee Mile	17.45
Location	Land Side
Category	Earthen Levee
Item	Encroachments

Agricultural ditch, photo taken in spring 2010.

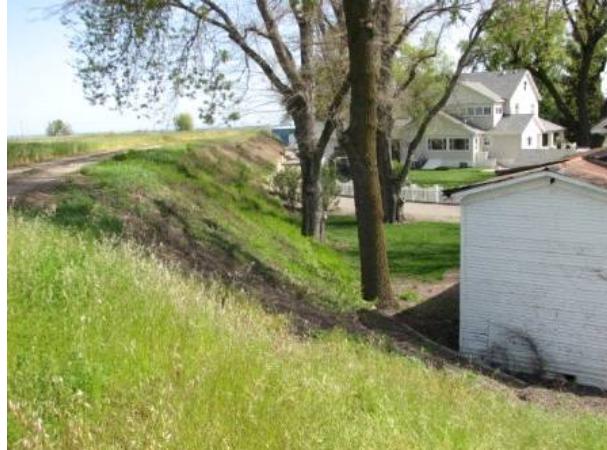
johngw_s_20120313_385.jpg

Building and wall into levee with landscape, photo taken in spring 2010.

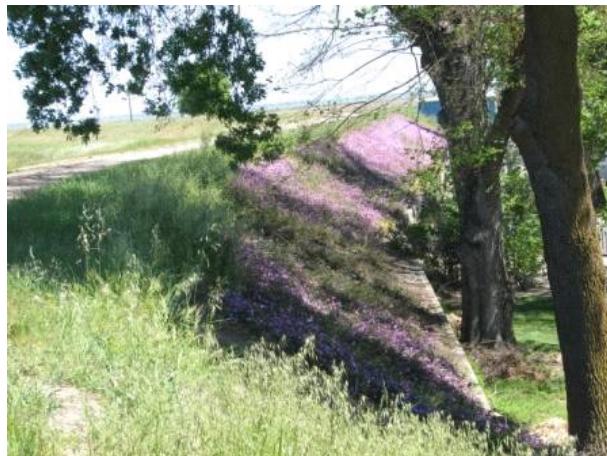
Levee Mile Report Line	78
Start Levee Mile	19.22
End Levee Mile	19.22
Location	Land Side
Category	Earthen Levee
Item	Vegetation

The groundcover is on the levee slope above the concrete retaining wall. The groundcover is irrigated.

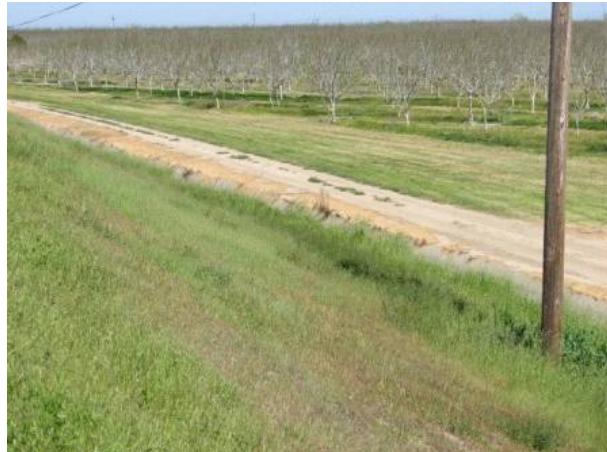
Levee Mile Report Line	81
Start Levee Mile	20.86
End Levee Mile	21.40
Location	Land Side
Category	Earthen Levee
Item	Encroachments
Agricultural ditch, photo taken in spring 2010.	
<i>johngw_s_20120313_429.jpg</i>

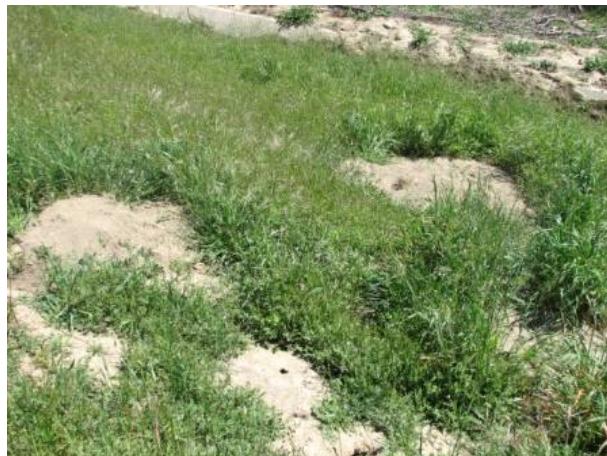
Levee Mile Report Line	82
Start Levee Mile	21.22
End Levee Mile	21.22
Location	Land Side
Category	Earthen Levee
Item	Animal Control
Rodent holes on the landside slope, photo taken spring 2012.	
<i>johngw_s_20120409_678.jpg</i>

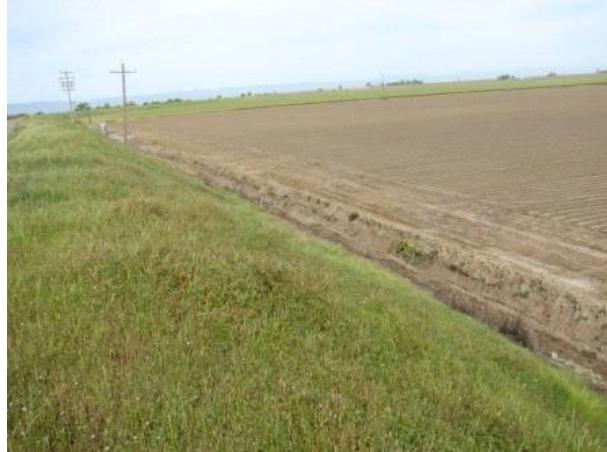
Levee Mile Report Line	84
Start Levee Mile	21.69
End Levee Mile	21.91
Location	Land Side
Category	Earthen Levee
Item	Encroachments
The agricultural ditch runs along the toe of the levee.	
<i>johngw_s_20120313_411.jpg</i>

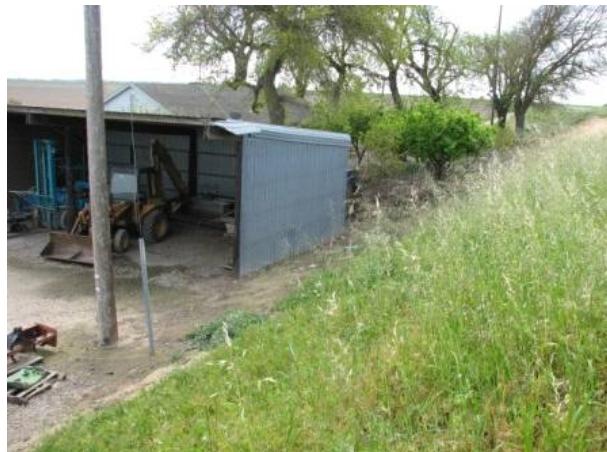
Levee Mile Report Line	87
Start Levee Mile	24.04
End Levee Mile	24.04
Location	Land Side
Category	Earthen Levee
Item	Encroachments
Pole barn and some equipment, photo taken in spring 2010.	
<i>johngw_s_20120313_391.jpg</i>

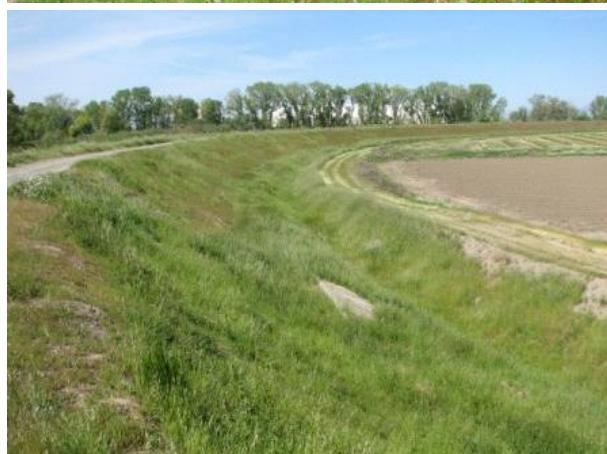
Levee Mile Report Line	88
Start Levee Mile	24.44
End Levee Mile	24.78
Location	Land Side
Category	Earthen Levee
Item	Encroachments
Agricultural ditch, photo taken in spring 2010.	
<i>johngw_s_20120313_430.jpg</i>

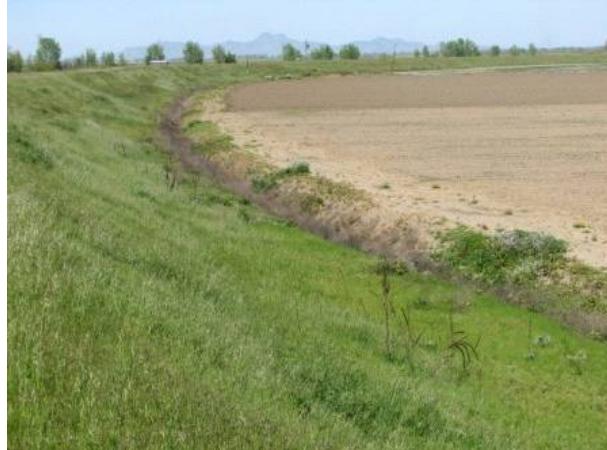
Levee Mile Report Line	91
Start Levee Mile	25.76
End Levee Mile	26.54
Location	Land Side
Category	Earthen Levee
Item	Encroachments
Agricultural ditch, photo taken in spring 2010.	
<i>johngw_s_20120313_431.jpg</i>

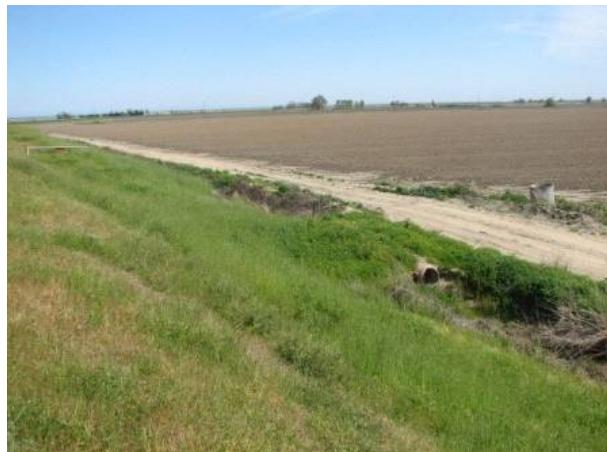
Levee Mile Report Line	93
Start Levee Mile	26.84
End Levee Mile	27.07
Location	Land Side
Category	Earthen Levee
Item	Encroachments
Agricultural ditch, photo taken in spring 2010.	
<i>johngw_s_20120313_432.jpg</i>

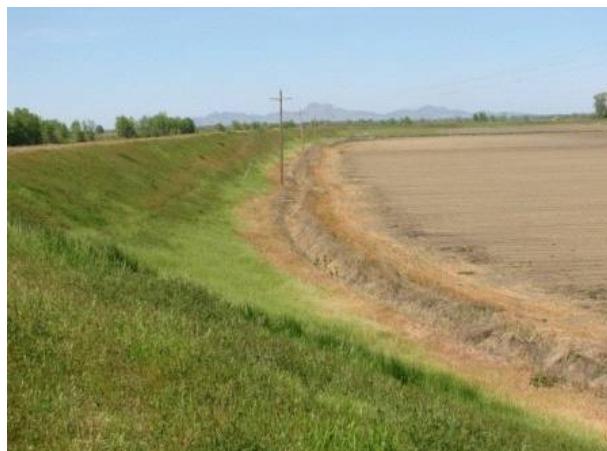
Levee Mile Report Line	94
Start Levee Mile	27.63
End Levee Mile	27.78
Location	Land Side
Category	Earthen Levee
Item	Encroachments
Agricultural ditch, photo taken in spring 2010.	
<i>johngw_s_20120313_433.jpg</i>

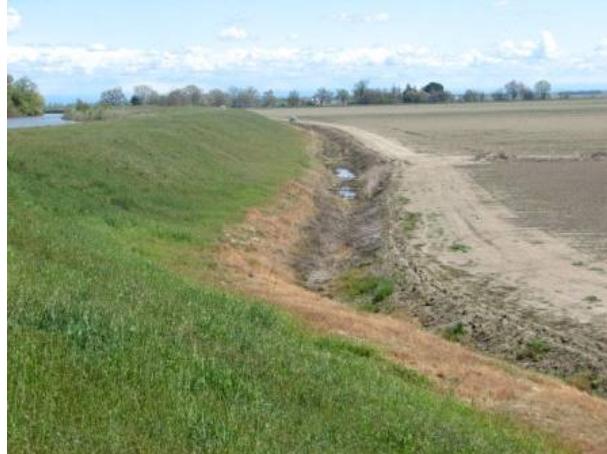
Levee Mile Report Line	95
Start Levee Mile	28.57
End Levee Mile	29.60
Location	Land Side
Category	Earthen Levee
Item	Encroachments
The agricultural ditch runs along the toe of the levee, photo taken spring 2012.	
johngw_s_20120409_680.jpg

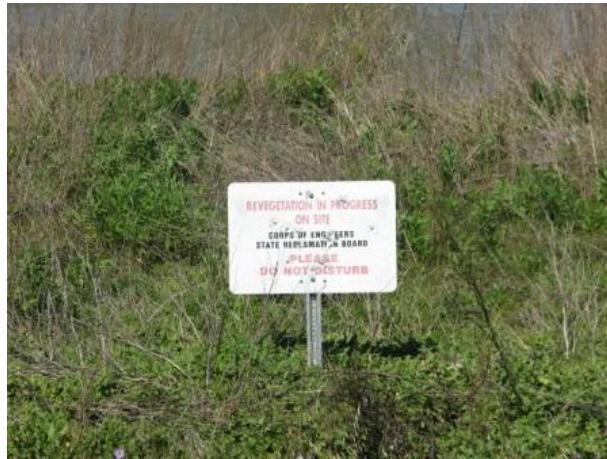
Levee Mile Report Line	97
Start Levee Mile	29.31
End Levee Mile	29.54
Location	Water Side
Category	Earthen Levee
Item	Vegetation
Another revegetation site on the waterside berm, photo taken spring 2012.	
johngw_s_20120409_681.jpg

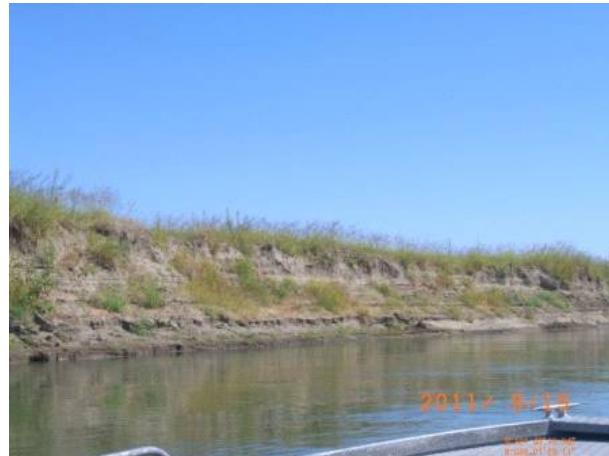
USACE 2011 Photo #2

Levee Mile Report Line	98
Start Levee Mile	29.56
End Levee Mile	29.56
Location	Water Side
Category	Supplemental
Item	USACE Erosion Survey

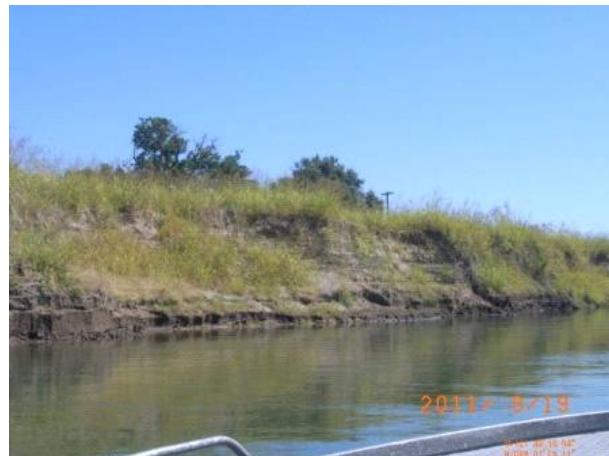
USACE 2011 Photo #3

Levee Mile Report Line	98
Start Levee Mile	29.56
End Levee Mile	29.56
Location	Water Side
Category	Supplemental
Item	USACE Erosion Survey

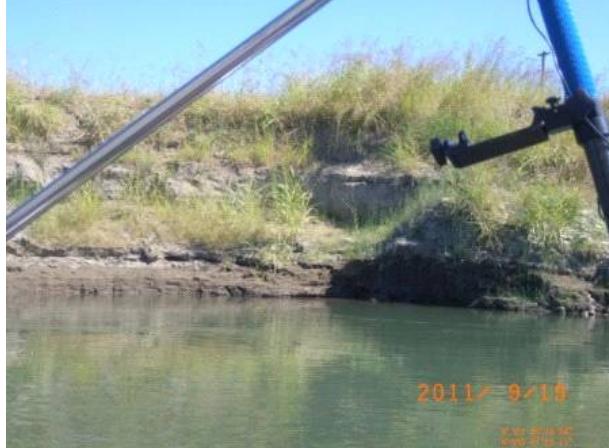
USACE 2011 Photo #4

Levee Mile Report Line	98
Start Levee Mile	29.56
End Levee Mile	29.56
Location	Water Side
Category	Supplemental
Item	USACE Erosion Survey

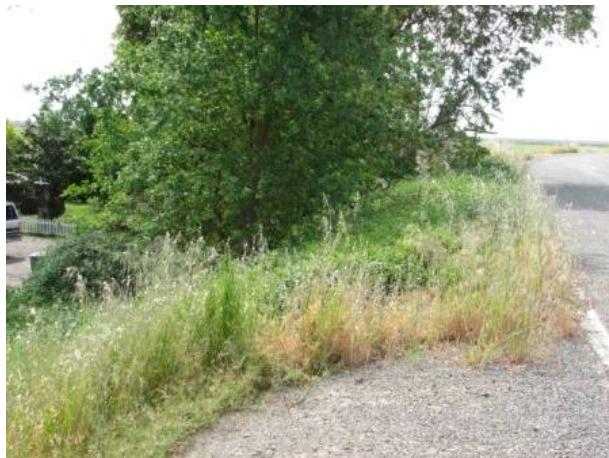
Levee Mile Report Line	100
Start Levee Mile	30.60
End Levee Mile	30.60
Location	Land Side
Category	Earthen Levee
Item	Vegetation

The groundcover in the landscape makes it hard to see the levee slope.

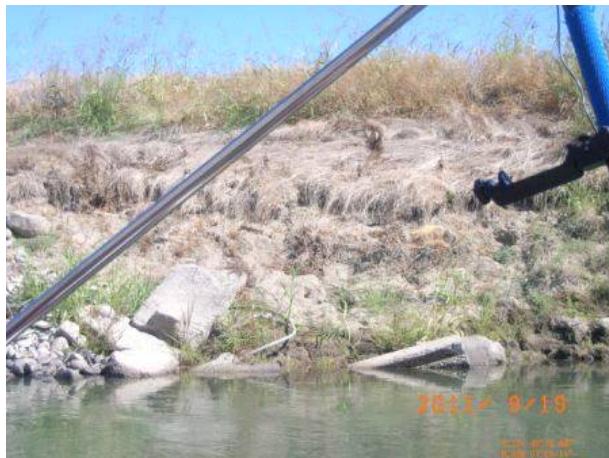
USACE 2011 Photo #1

Levee Mile Report Line	102
Start Levee Mile	30.91
End Levee Mile	30.91
Location	Water Side
Category	Supplemental
Item	USACE Erosion Survey

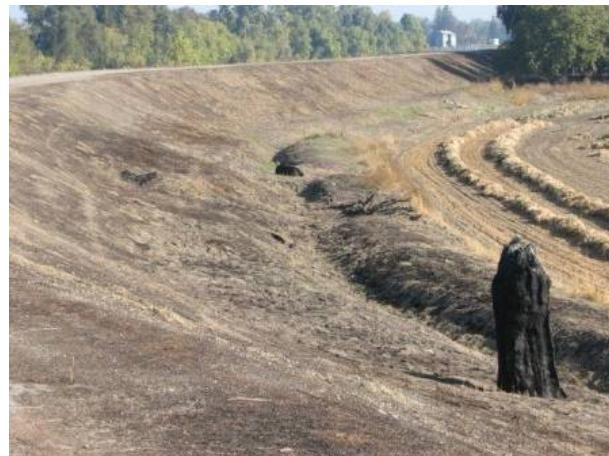
Older, unused agricultural ditch. Tree stump
needs to be removed.

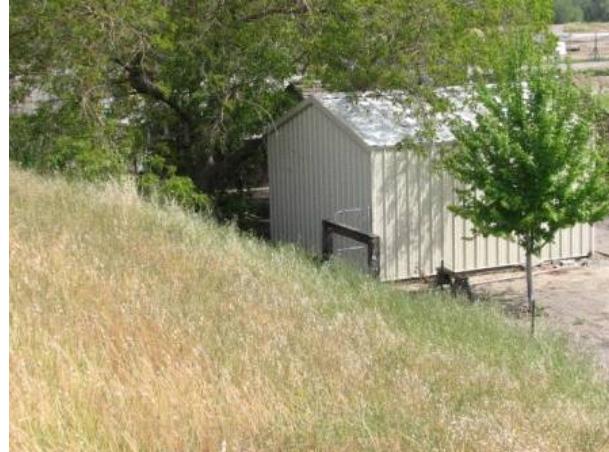
Levee Mile Report Line	106
Start Levee Mile	33.33
End Levee Mile	33.33
Location	Land Side
Category	Earthen Levee
Item	Encroachments
The building is within the easement of the levee toe.	
johngw_s_20120313_397.jpg

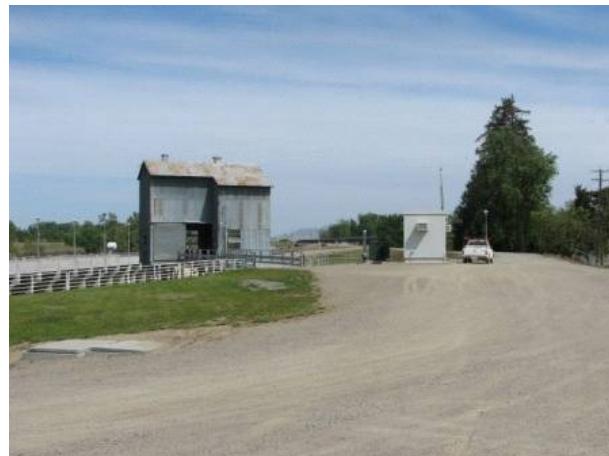
Levee Mile Report Line	107
Start Levee Mile	33.41
End Levee Mile	33.41
Location	Water Side
Category	Earthen Levee
Item	Encroachments
The buildings are on the waterside of the crown. Control buildings for the pumping plant.	
johngw_s_20120313_399.jpg
